**ORLEANS PARISH
DRAINAGE PUMPING STATIONS**

KATRINA DAMAGE REPAIR

**U. S. ARMY CORPS OF ENGINEERS
NEW ORLEANS DISTRICT**

February 15, 2006

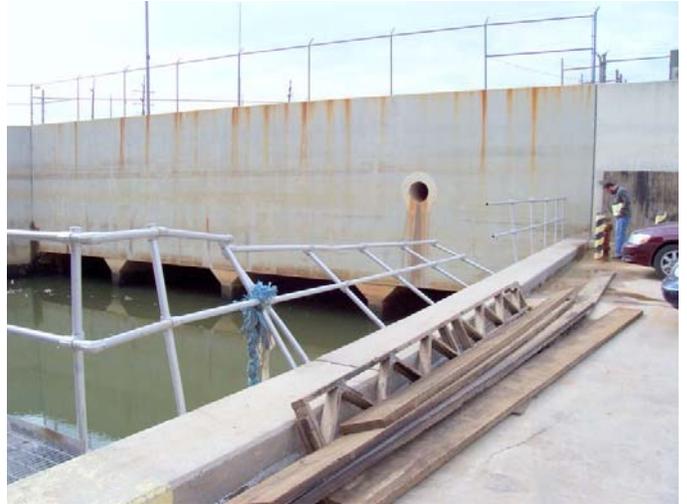
Photo 2 – Damaged pipe rail.

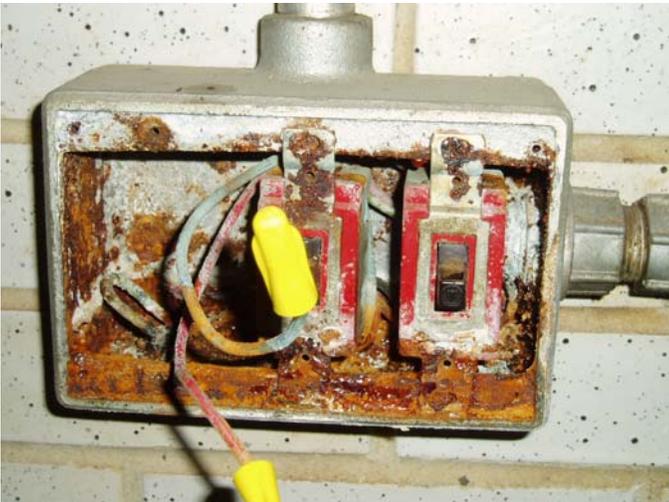
Photo 3 – Damaged low voltage lighting below operating floor.

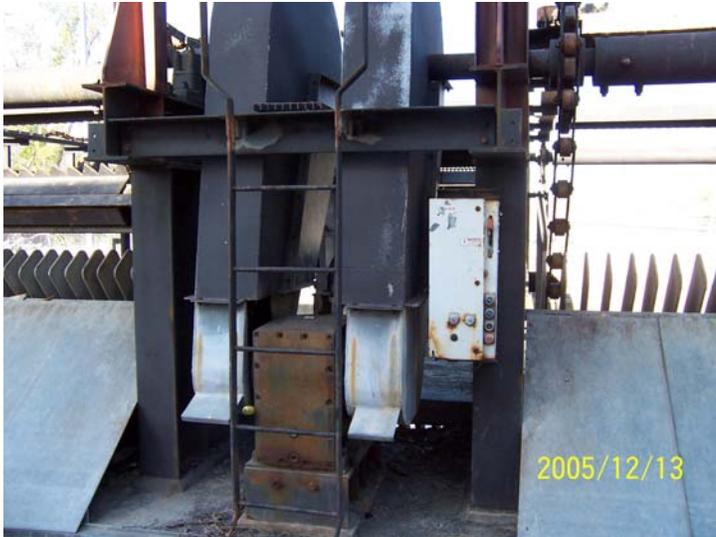
Photo 1 – Damaged control panel for trash screen motor.

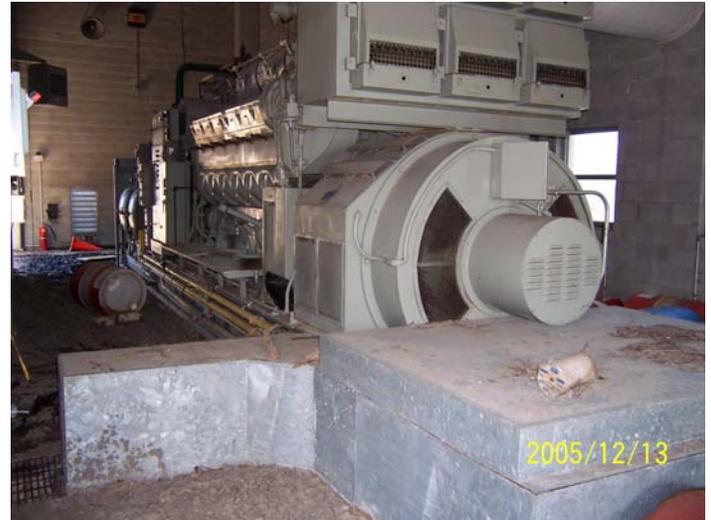
Photo 2 – Damaged diesel engine for generator.

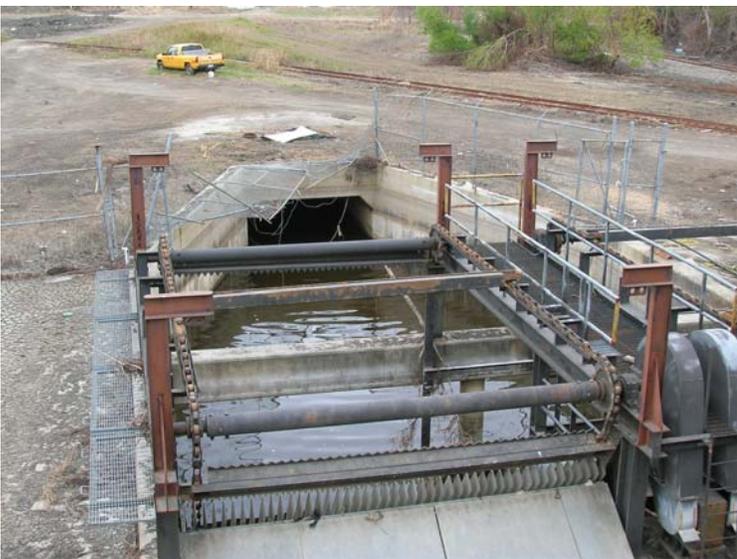
Photo 3 – Damaged fence.

7. An enclosed steel ladder was torn off the office building. This should be reinstalled.
8. About 300 lf of 8' chain link fence with 3 strands of barbed wire along the top is damaged. Replacement in kind is recommended.
- 9 One light pole at the suction basin was damaged and should be replaced.

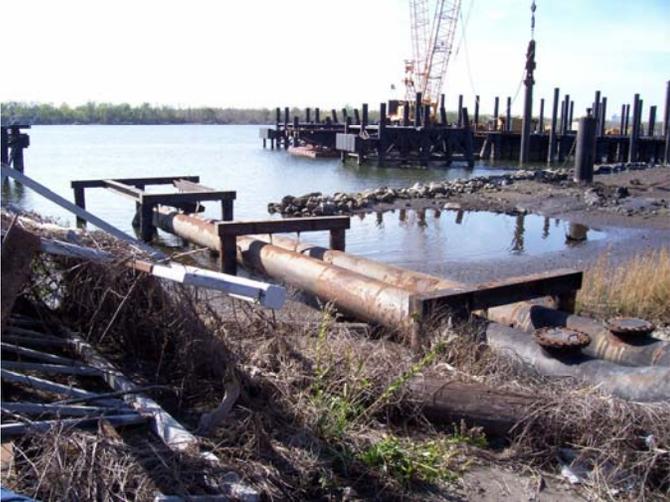
Photo 1 – Damaged steel support straps for discharge pipe.

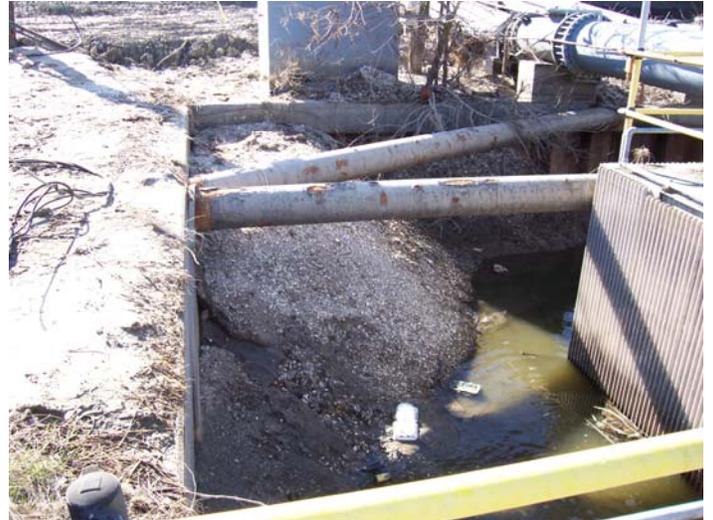
Photo 2 – Debris in intake channel.

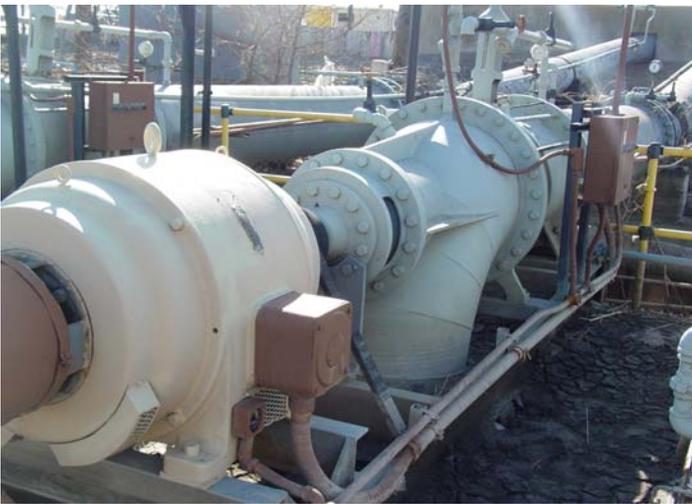
Photo 3 – Replace pump bearings.

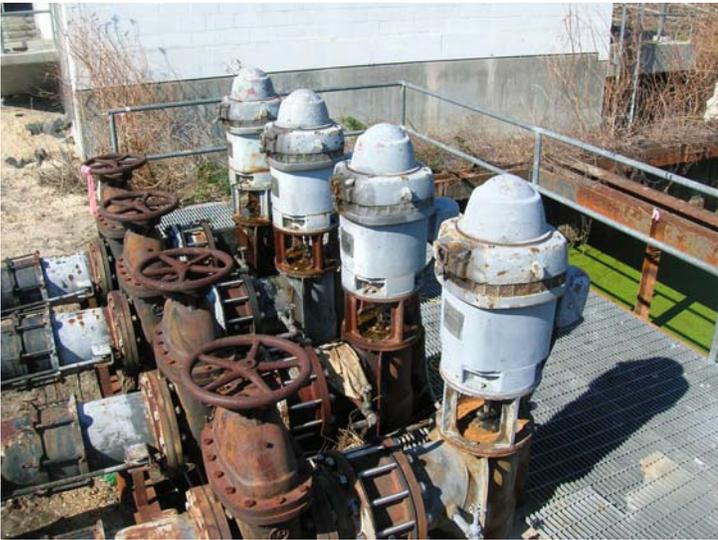
Photo 1 – Replace pump motors 1, 2, 3, 4.

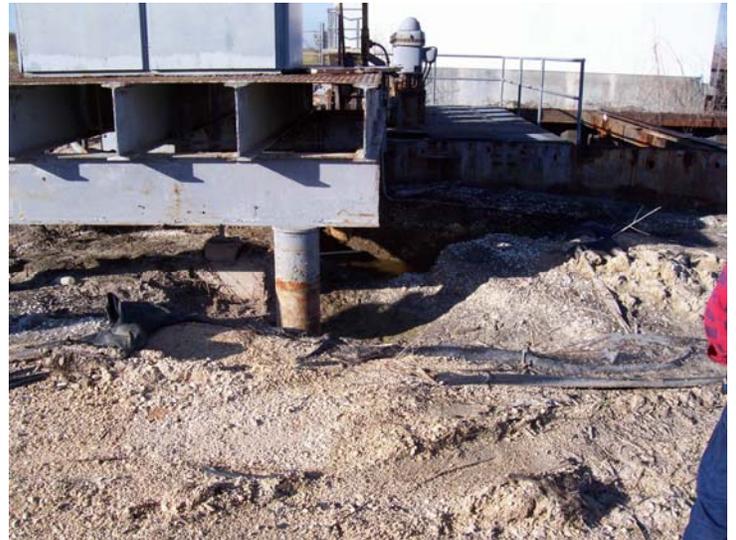
Photo 2 – Site erosion and required grading.
